# Tree Grille Tree Grate

## **Design Anders Nyquist**

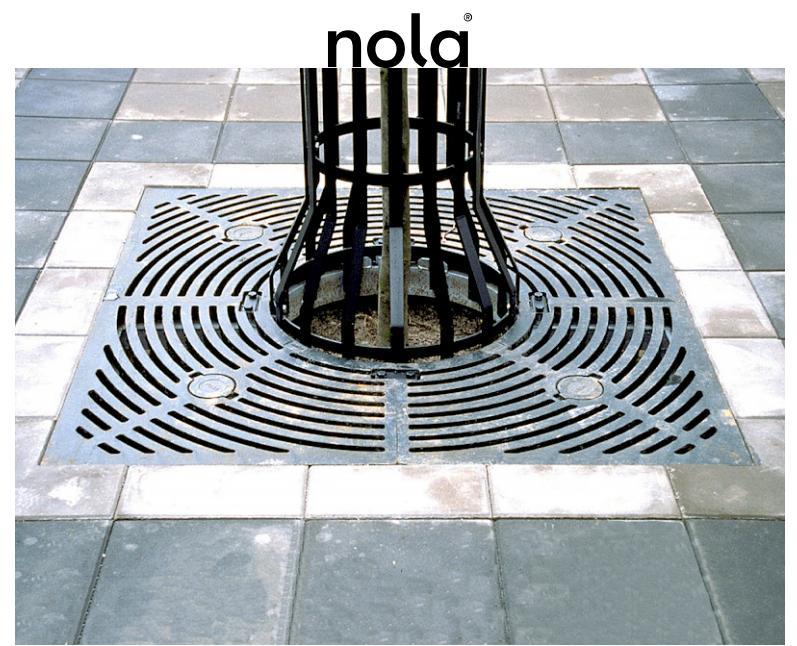
This iron tree grate is installed at the same level as the pavement surrounding the tree. The tree grate allows the soil underneath it to remain uncompacted, encouraging healthy roots. The grate allows the tree roots to absorb water, air and sunlight while protecting them from pedestrians and traffic. Able to withstand weights up to 12 tonnes, the tree grate is strong enough to resist the pressure created by growing tree roots that can break many similar products.

Dimensions and weight	TREE GRILLE Length: 140 cm Width: 140 cm Depth: 5 cm Weight of each component: 76 kg Number of components: 4
	SUB-FRAME Length of sub-frame: 140 cm Width of sub-frame: 140 cm Depth: 8 cm Weight of each component: 37 kg Number of components: 2
	ROOT BARRIER Length: 140 cm Width: 140 cm Depth: 60 cm Weight of each component: 145 kg Number of components: 5
Product numbers and combinations	Ö30-71 Markgaller. Ö30-71BT80 Bevattningstank, 80lit. Ö30-72 Beslagssats till markgaller, sats om 4 st. Ö30-73 Underkonstruktion. Ö30-75 Trio-lyft. Ö30-76 Betonglåda för markgaller.
Standard colours	
Materials and surface treatments	The tree grille is made from cast iron with a thickness of 50/44 cm. The sub-frame is made from hot-dip galvanized steel with U-beam USP80. The root control barrier is made from reinforced concrete with a thickness of 10 cm (there are openings in the bottom to enable roots to grow deeper).

Assembly and placement	The surface grille's own weight is substantial enough to secure it to the sub-frame without fittings. If it is installed without the sub-frame we recommend securing it with metal fittings Ö30-72, which you will need to include in your order.
