nola®

## Motala Tree Guard

Design Olle Anderson

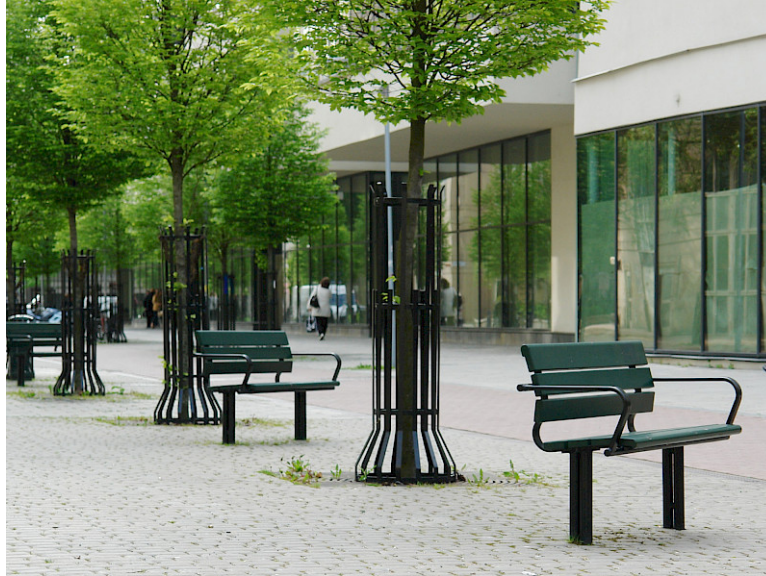
Motala is a classic tree guard that encases the tree in a protective metal cage. Taller than many other tree guards, Motala offers excellent protection for bigger trees too. The tree guard is widest at the bottom, where it is reinforced with more steel ribs. The design provides an attractive complement to historic centres and too contemporary streetscapes too.

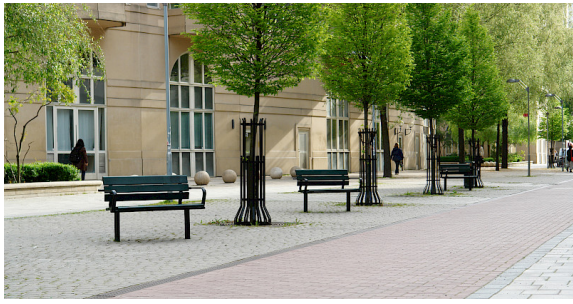
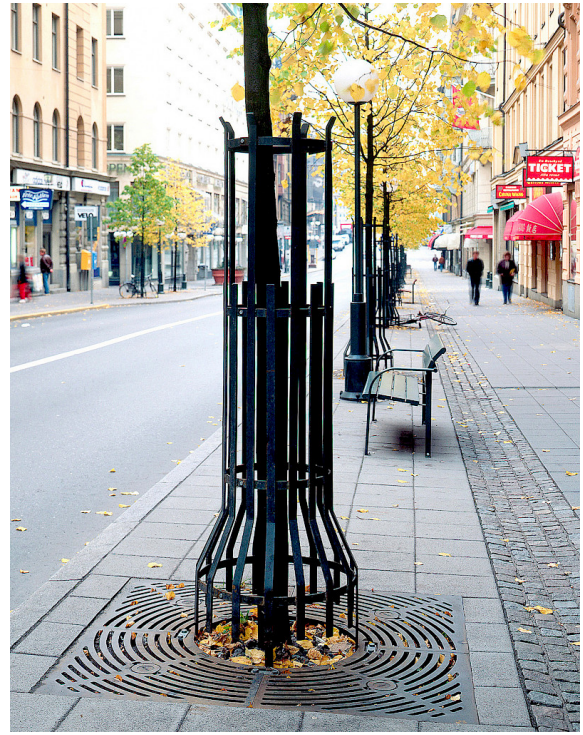
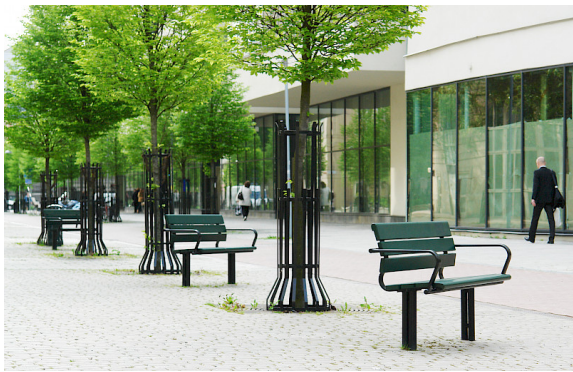
## Dimensions and weight

Height: 180 cm

Total height: 220 cm. Depth below ground: 40 cm. Top diameter: 40 cm. Base diameter: 60 cm. Inner diameter: 37 cm.

The steel strips: 30 mm x 6 mm and 30 mm x 8 mm respectively.
